Manhole Inspection Summary

Manhole # S25G__042MH

Insp Date: 1/13/09 11:44 AM

Location Address: **1100 BOOTH ST**

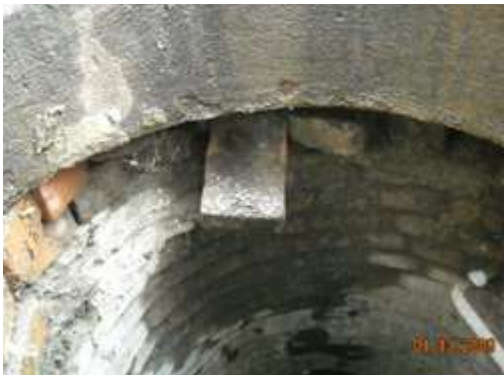
Defect 6

Condition: ☐ Sound ☐ Cracked ☐ Root Intrusion ☒ **Loose Brick** ☒ **Deteriorated**

LOOSE CHIMNEY BRICK

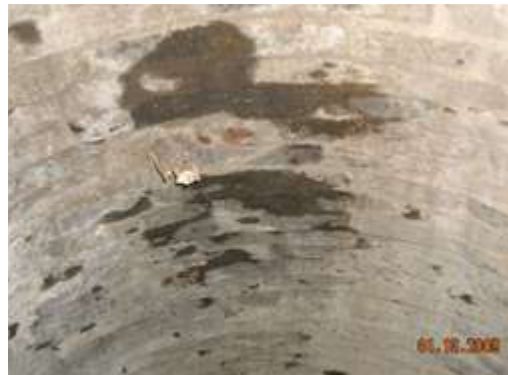
Defect 4

Infiltration: ☐ None ☐ Joint ☐ Cracks ☐ Mortar ☐ Roots ☒ **Wall**

INFILTRATION @ CORBEL WALL

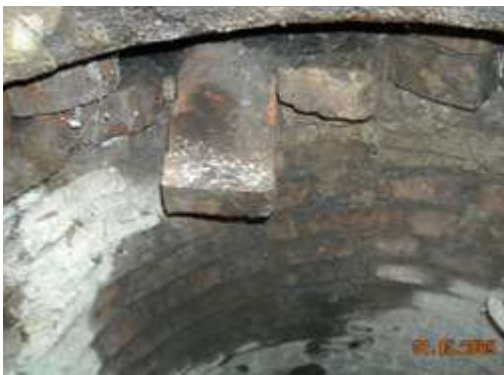
Defect 3

Infiltration: ☐ None ☒ **Joint** ☐ Cracks ☐ Mortar ☐ Roots ☐ Wall

INFILTRATION @ CHIMNEY JOINT,
chimney is deteriorated with loose bricks

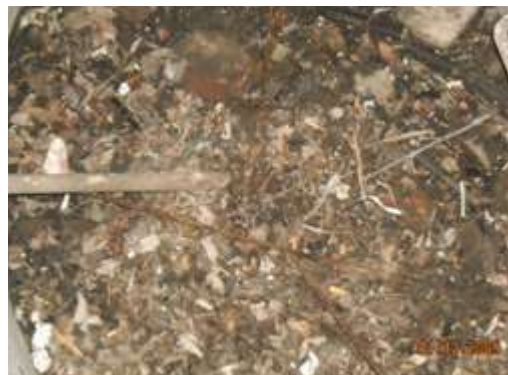
Defect 1

Condition: ☐ Sound ☐ Cracked ☐ Root Intrusion ☐ Deteriorated ☐ Leaks ☒ **Debris**

DEBRIS IN TERMINAL CHANNEL

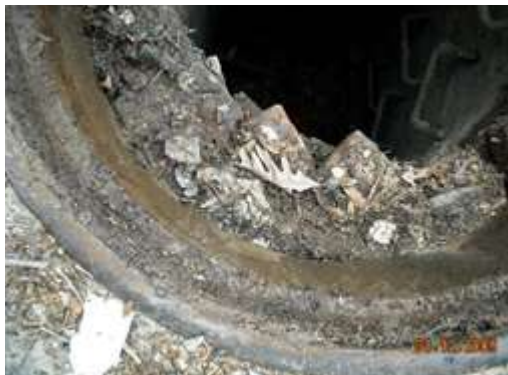
Frame Offset: **5** (in.) Condition: ☒ Sound ☐ Cracked ☐ Leaks

FRAME OFFSET
